Manhole Inspection Summary

Manhole # S35YY_014MH

Location Address: **101 33RD ST**

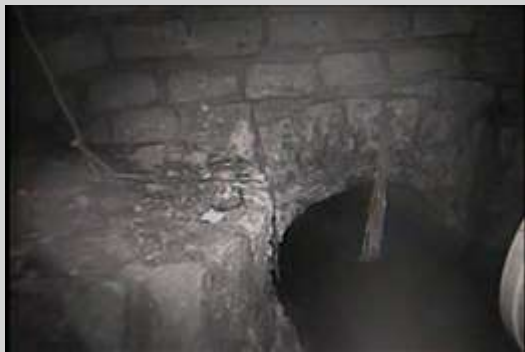
18 in. Circular Gravity Sewer Pipe Out @ 12 O'Clock

Pipe Material: **Clay** ☐ Pipe Lined

Invert Depth: **14.25** (ft.) Flow Characteristics: **Fast**

Infiltration: **None** Pipe Seal Cond: **Unknown**

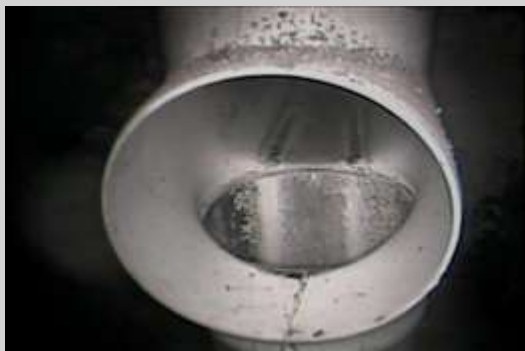
8 in. Circular Gravity Sewer Pipe In @ 3 O'Clock

Pipe Material: **Clay** ☐ Pipe Lined

Invert Depth: **9.53** (ft.) Flow Characteristics: **Slow**

Infiltration: **None** Pipe Seal Cond: **Sound**

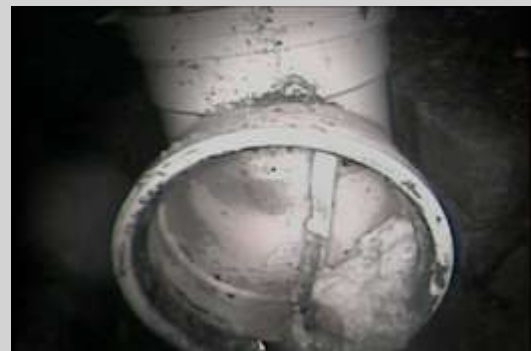
Drop In @ 3 O'Clock

Drop: **Inside** Rod and Bar
Angled: **Yes** Reading: **11.73** (ft.)
Inv Depth: **12.73** (ft.)

Drop Condition: **Open**

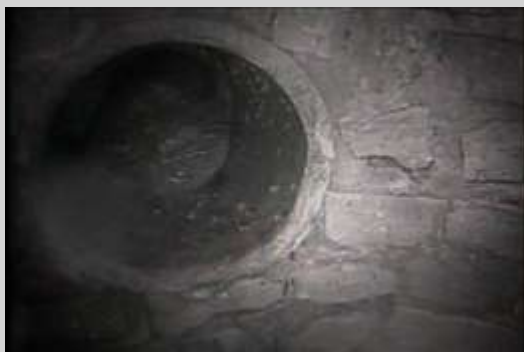
8 in. Circular Gravity Sewer

Pipe Material: **Clay** ☐ Pipe Lined

Infiltration: **None** Pipe Seal Cond: **Unknown**
